2020 ANNUAL REPORT

TENNESSEE STATE BUILDING COMMISSION

Prepared by Tony Guzzi, Vice-President, Preservation and Site Operations
Andrew Jackson's Hermitage | Andrew Jackson Foundation
4580 Rachel's Lane, Hermitage, TN 37076
615.889.2941 ext. 225 | Fax 615.889.9289
tguzzi@thehermitage.com

This Annual Report to the Tennessee State Building Commission (SBC) describes preservation and significant maintenance and management work completed on historic and cultural resources at Andrew Jackson's Hermitage by the Andrew Jackson Foundation (AJF) in calendar year 2020 and proposed work for calendar year 2021. This annual report submission is required under Tennessee Code Annotated section 4.13.104. The following is a brief description of proposed property acquisition, construction, demolition, alteration, restoration, or preservation works in progress. Projects involving routine maintenance and minor repairs are not included. Projects are listed in order of priority.

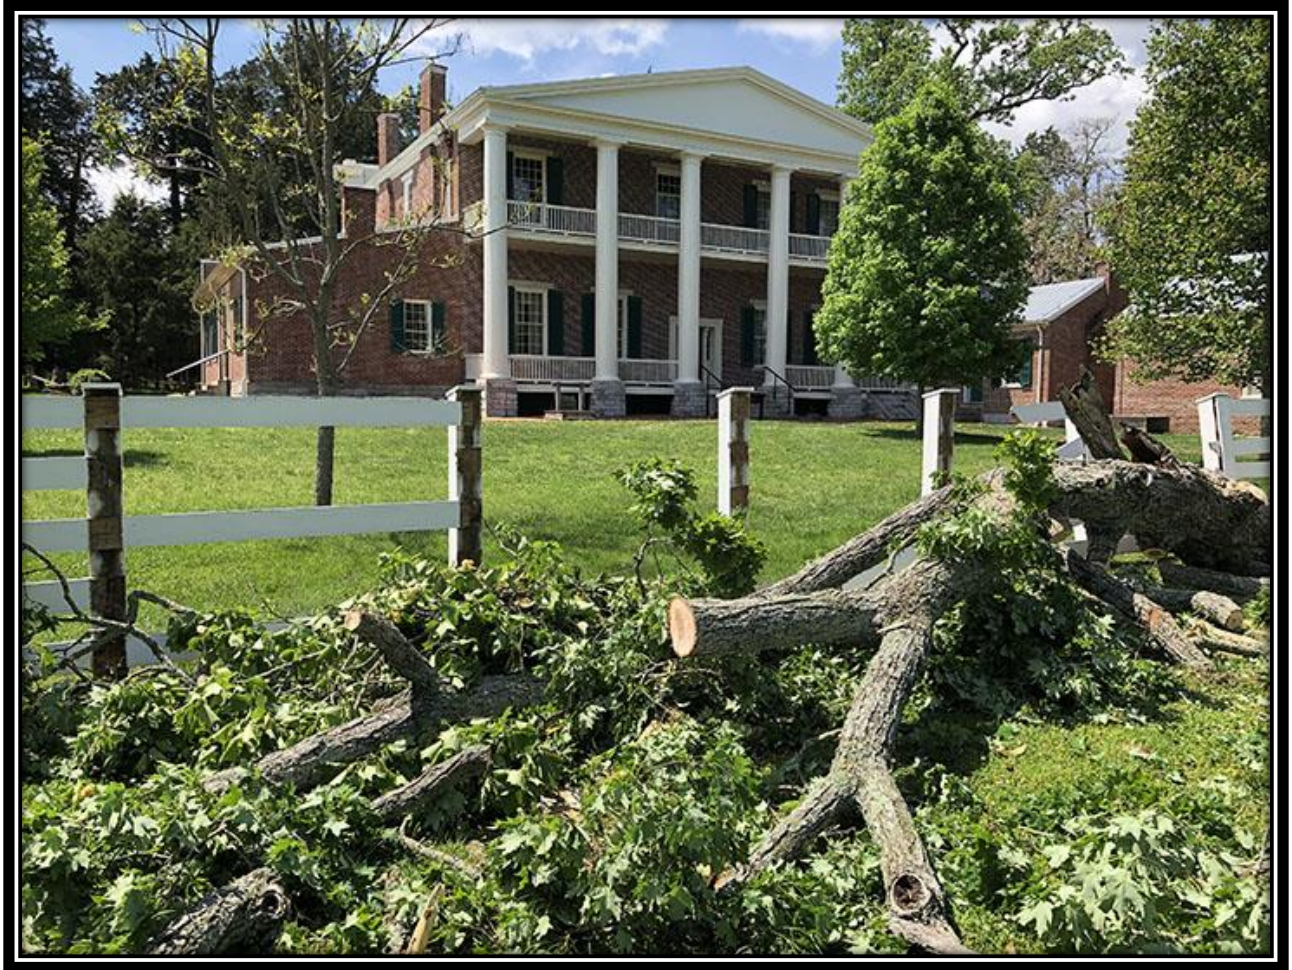
A 100-year-old sugar maple to the rear of the Hermitage mansion lost the bulk of its crown during the May 3, 2020 Derecho.
